“SAVJETOVANJE 4: OBNOVA  
ZAGREBA NAKON POTRESA  
— ZAGREBU OD SPLITA”

PROCJENA POTRESNE RANJVOSTI I  
NOSIVOSTI ZGRADA KAO  
PREDUVJET SPRJEČAVANJA,  
UPRAVLJANJA I PREVLADAVANJA  
POTRESNOG RIZIKA U POVIESnim  
GRADSKIM SREDIŠTIMA

Prof. dr. sc. Željana Nikolić  
Sveučilište u Splitu, FGAG  
Katedra za teoriju konstrukcija  
Split, Hrvatska

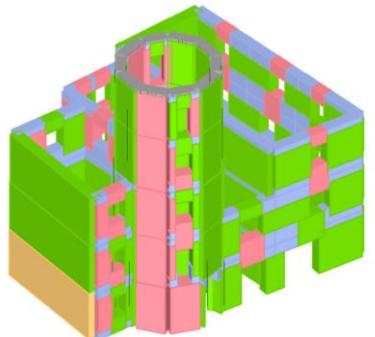
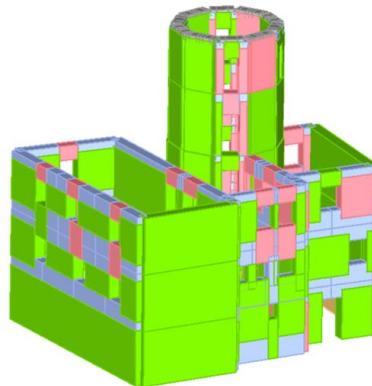
## Smjer x – br.16, modalna raspodjela

dt	0,86	[cm]	>	dm	0,45	[cm]
qu =	1,58			dm/dt =	0,52

**Not satisfied verification**

$a_u = 0.078 g$

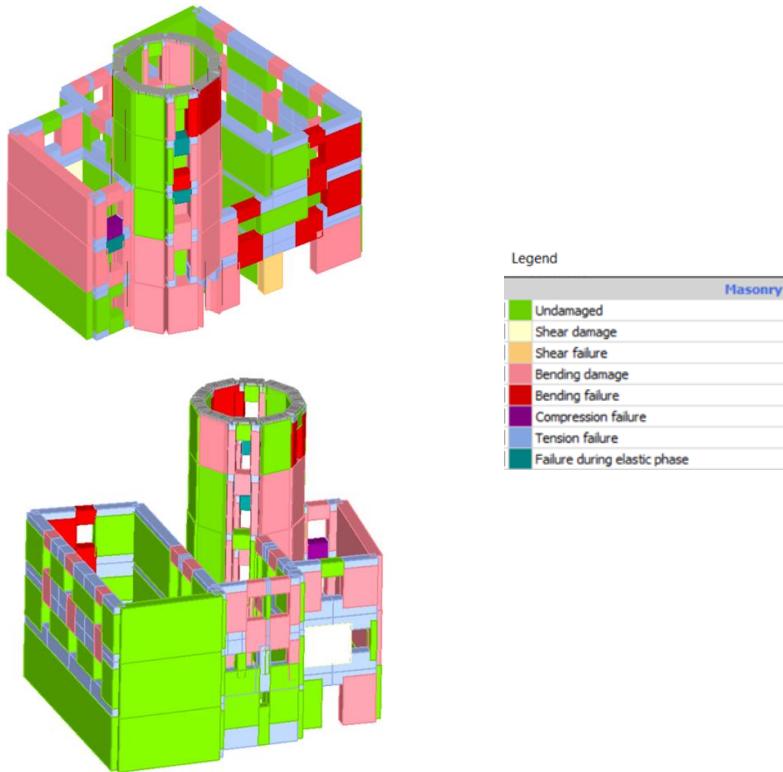
## Smjer y – br.19, linearna raspodjela

NC		
dt	5,88 [cm]	> dm 2,10 [cm]
qu =	2,80	dm/dt = 0,36
Not satisfied verification		
SD		
dt	5,88 [cm]	> dm 1,58 [cm]
Not satisfied verification		
DL		
Sd	1,30 [cm]	> d*y 0,93 [cm]
Not satisfied verification		
Limit state	PGA [m/s <sup>2</sup> ]	$\alpha$
NC	0,768	0,357
SD	0,576	0,268
DL	0,768	0,711

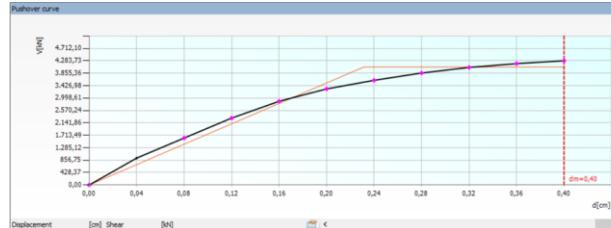
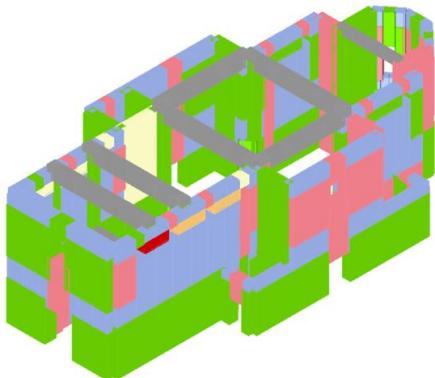
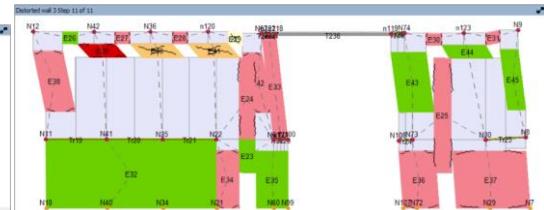
Smjer y

$dt = 1,23 \text{ [cm]}$  >  $dm = 0,40 \text{ [cm]}$   
 $qu = 3,03$   $dm/dt = 0,33$

**Not satisfied verification**

$dt = 1,23 \text{ [cm]}$  >  $dm = 0,30 \text{ [cm]}$   
**Not satisfied verification**

$Sd = 0,29 \text{ [cm]}$  >  $d^*y = 0,19 \text{ [cm]}$   
**Not satisfied verification**

$$a_u = 0.091 \text{ g}$$
